ATTACHMENT 2: INSPECTION PHOTOGRAPHS

ATTACHMENT 3: CONFIDENTIALITY NOTICE

ATTACHMENT 4: FIELD SAMPLING RESULTS

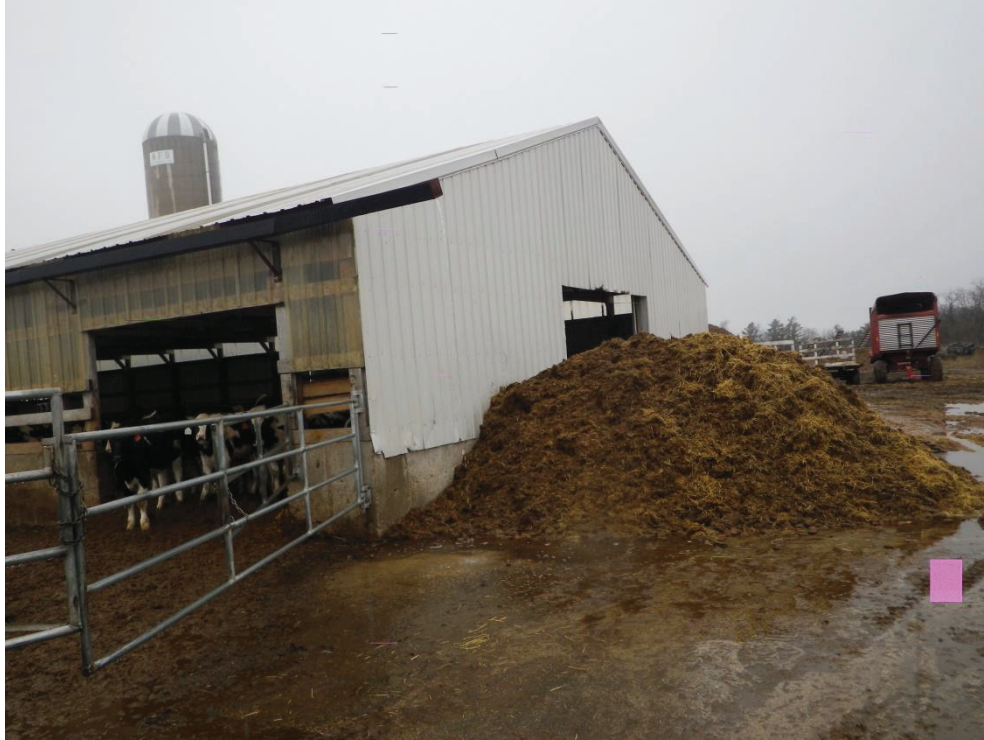
1: IMGP0254.JPG

Description: A stockpile of used bedding material was located east of Calf Barn 2. The process wastewater from the open lot and stockpile had no containment and could flow east off site to unnamed tributary on the east side of the site.

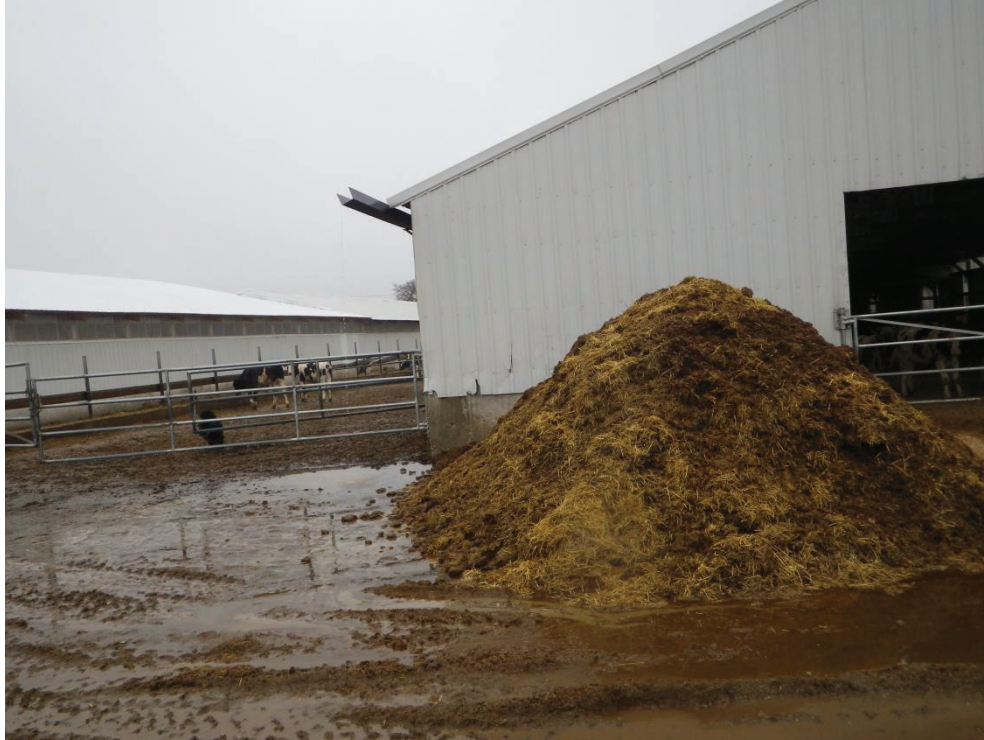
2: IMGP0255.JPG

Description: A stockpile of used bedding material was located east of Calf Barn 2. The process wastewater from the open lot and stockpile had no containment and could flow east off site to unnamed tributary.

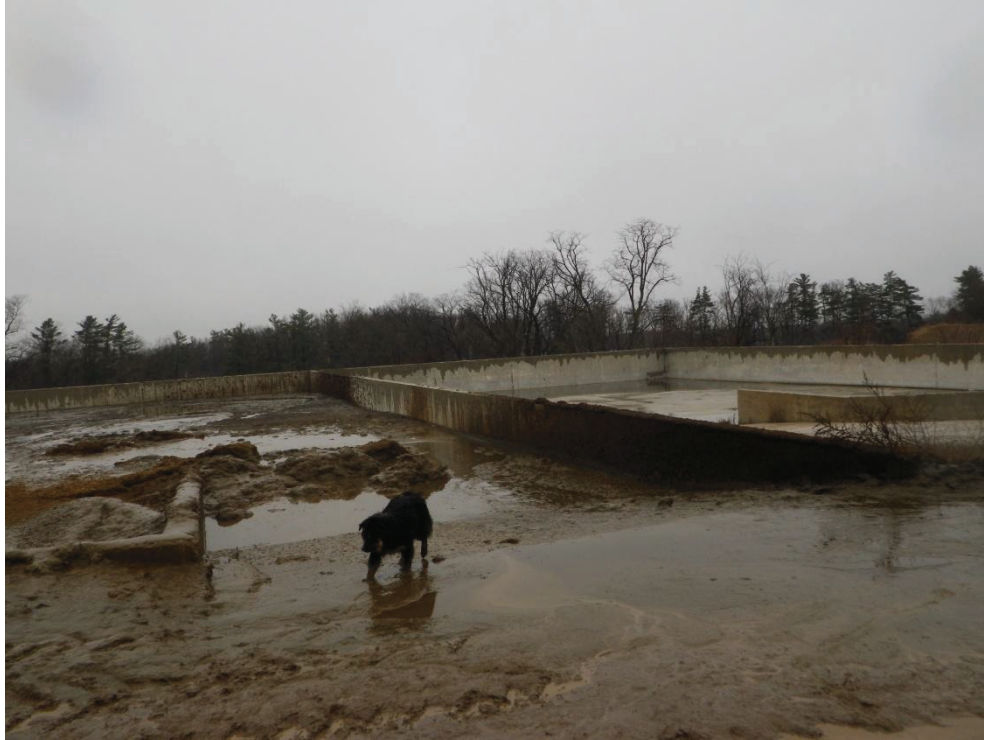
3: IMGP0256.JPG

Description: The west concrete pit was approximately half full. The east concrete pit was nearly empty. The water in the east pit was dark and smelled septic.

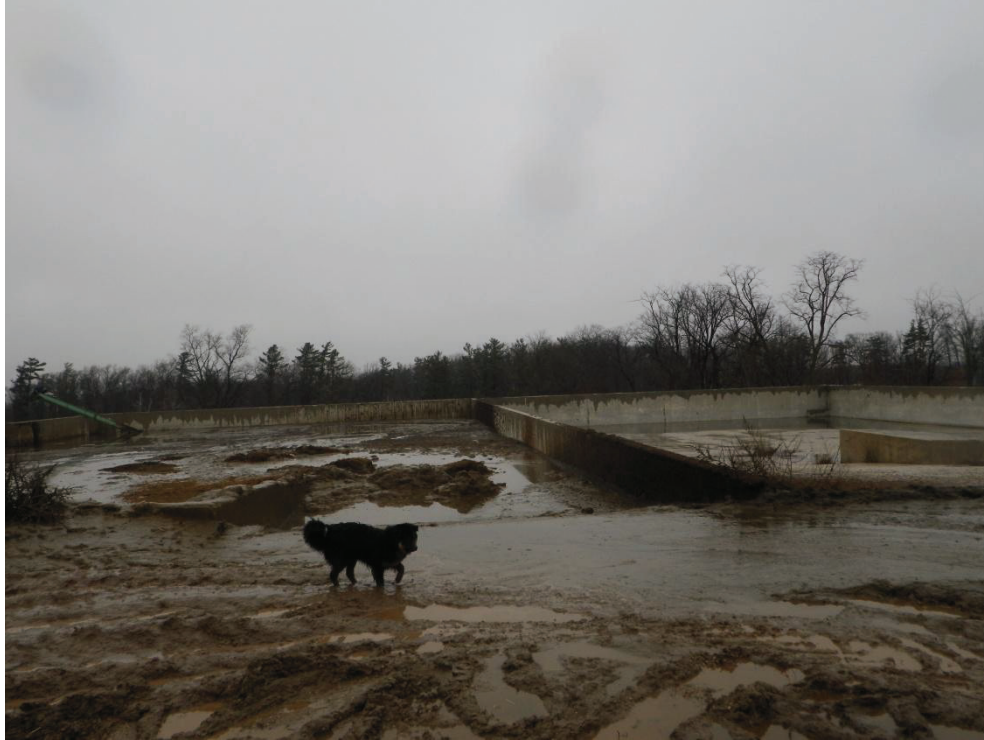
4: IMGP0257.JPG

Description: The west concrete pit was approximately half full. The east concrete pit was nearly empty. The water in the east pit was dark and smelled septic.

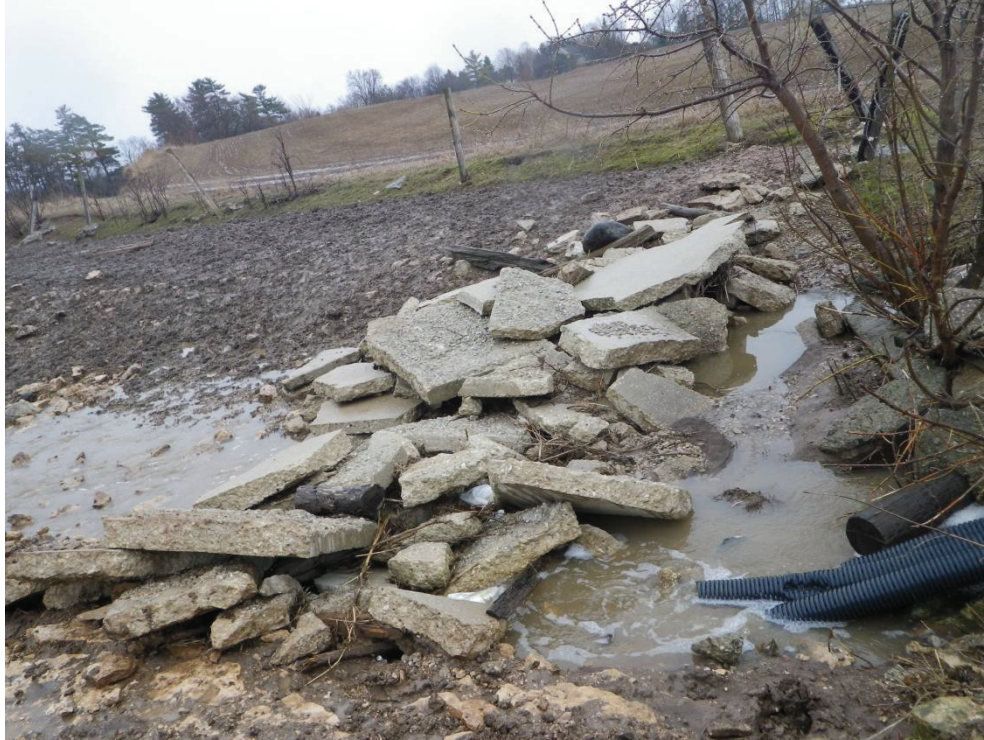
5: IMGP0258.JPG

Description: An unnamed tributary flows along the east end of the production area. Cattle had direct access to the unnamed tributary through an open lot. Manure was observed in and around the tributary.

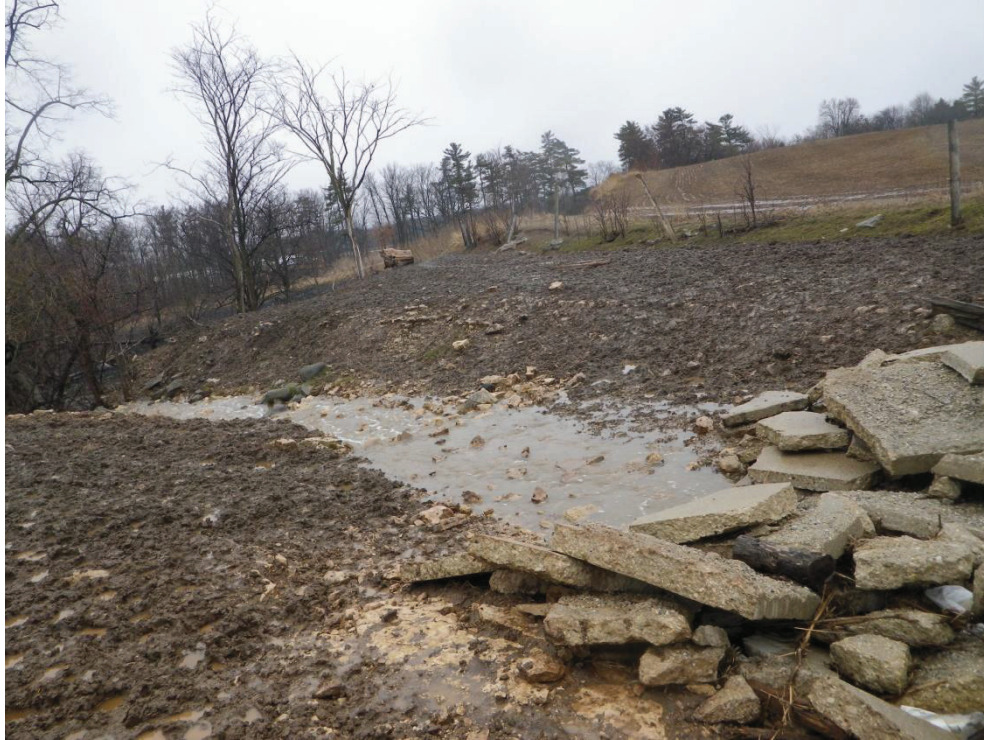
6: IMGP0259.JPG

Description: An unnamed tributary flows along the east end of the production area. Cattle had direct access to the unnamed tributary through an open lot. Manure was observed in and around the tributary.

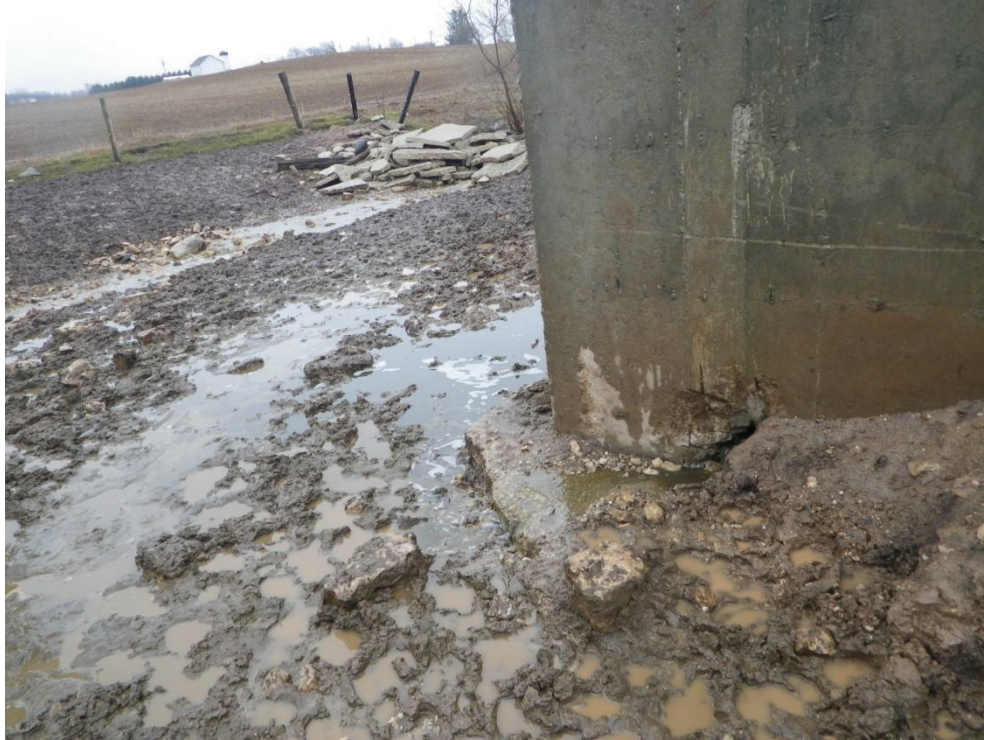
7: IMGP0260.JPG

Description: A hole was observed in the corner of the east concrete pit. Mr. [REDACTED] said the pit was currently not used for manure storage. The discharge from the hole in the pit was dark in color and had a septic smell of wastewater. The flow from the hole in the east concrete pit flowed east and entered the unnamed tributary.

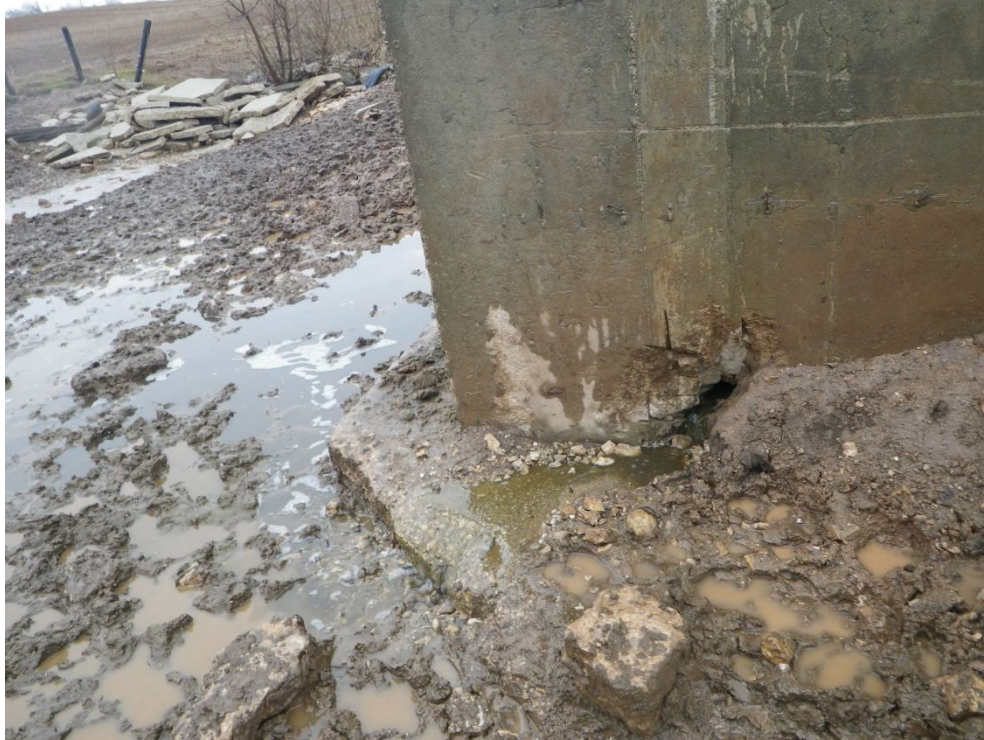
8: IMGP0261.JPG

Description: A hole was observed in the corner of the east concrete pit. Mr. [REDACTED] said the pit was currently not used for manure storage. The discharge from the hole in the pit was dark in color and had a septic smell of wastewater. The flow from the hole in the east concrete pit flowed east and entered the unnamed tributary.

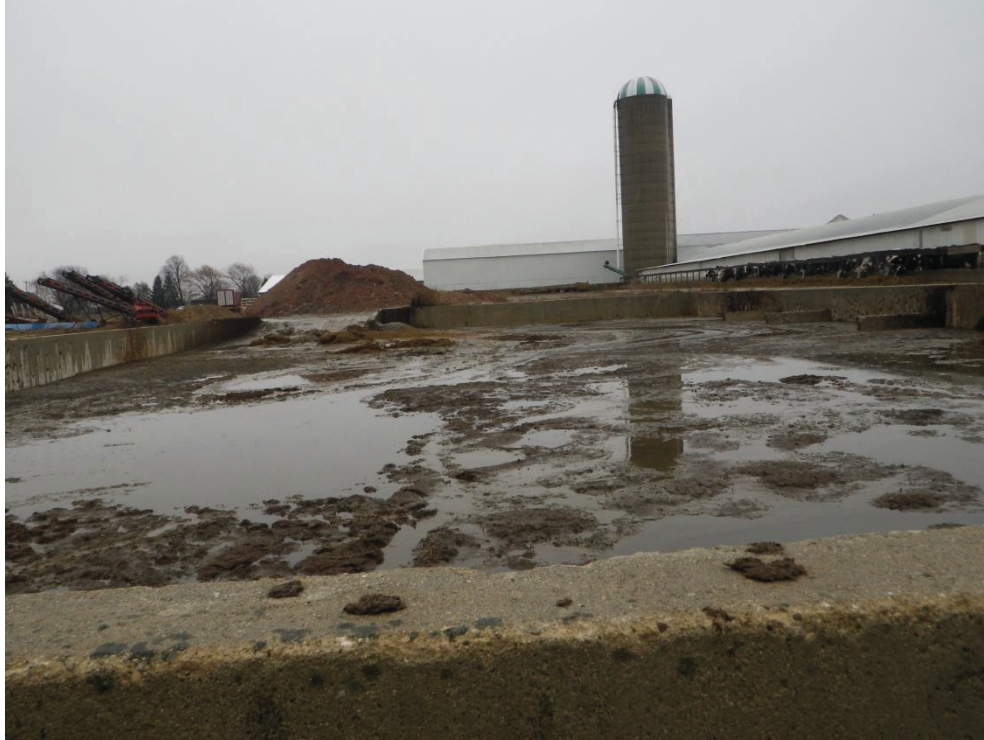
9: IMGP0262.JPG

Description: The west concrete manure storage pit was approximately half full.

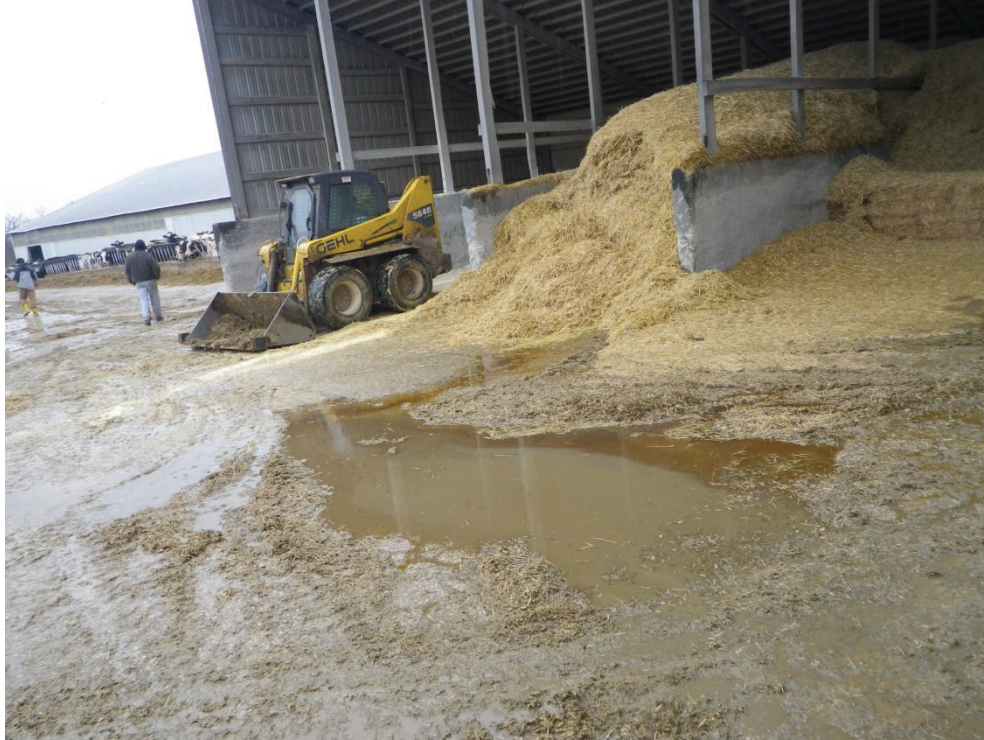
10: IMGP0263.JPG

Description: Track out of feed was located on the access way from the commodity storage area. The process wastewater flowed north.

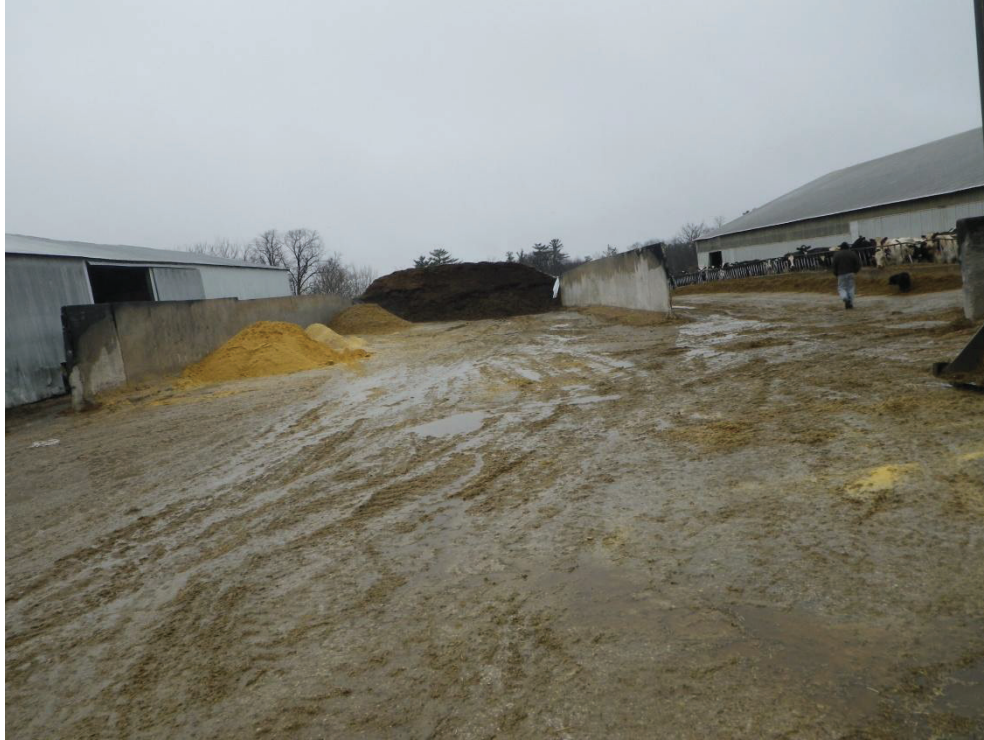
11: IMGP0264.JPG

Description: The feed storage bunker did not have containment for process wastewater. Feed was observed on the ground throughout the area. The area drains to the north.

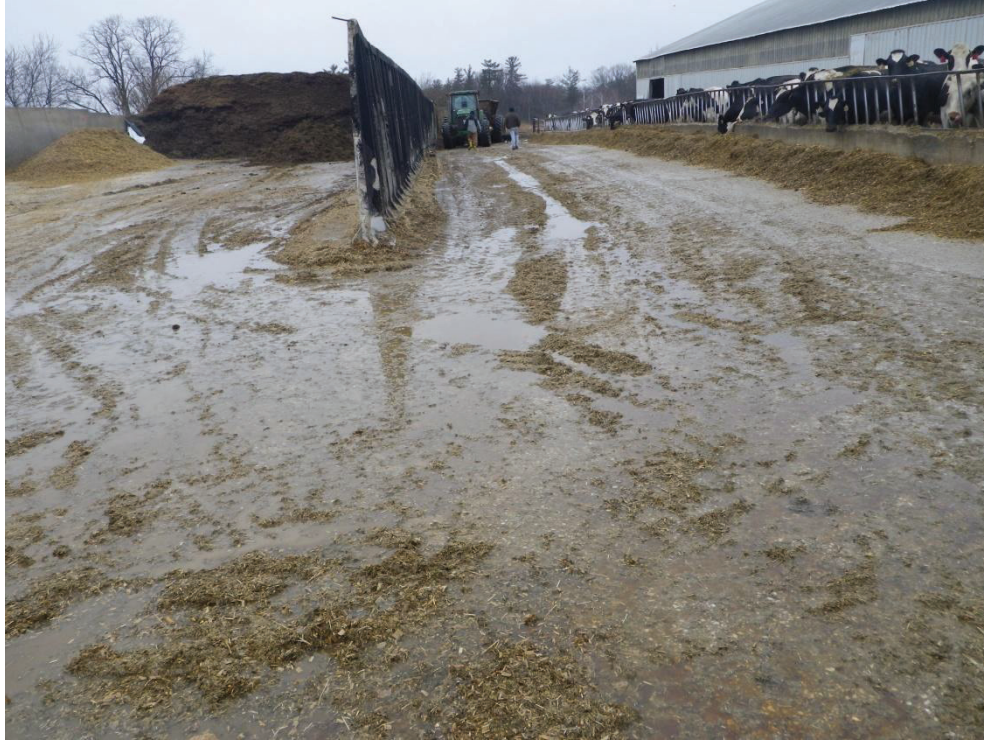
12: IMGP0265.JPG

Description: The access way contained feed solids and process wastewater that flowed to the north. The open lot did not have containment for manure and process waste water; the runoff flows north.

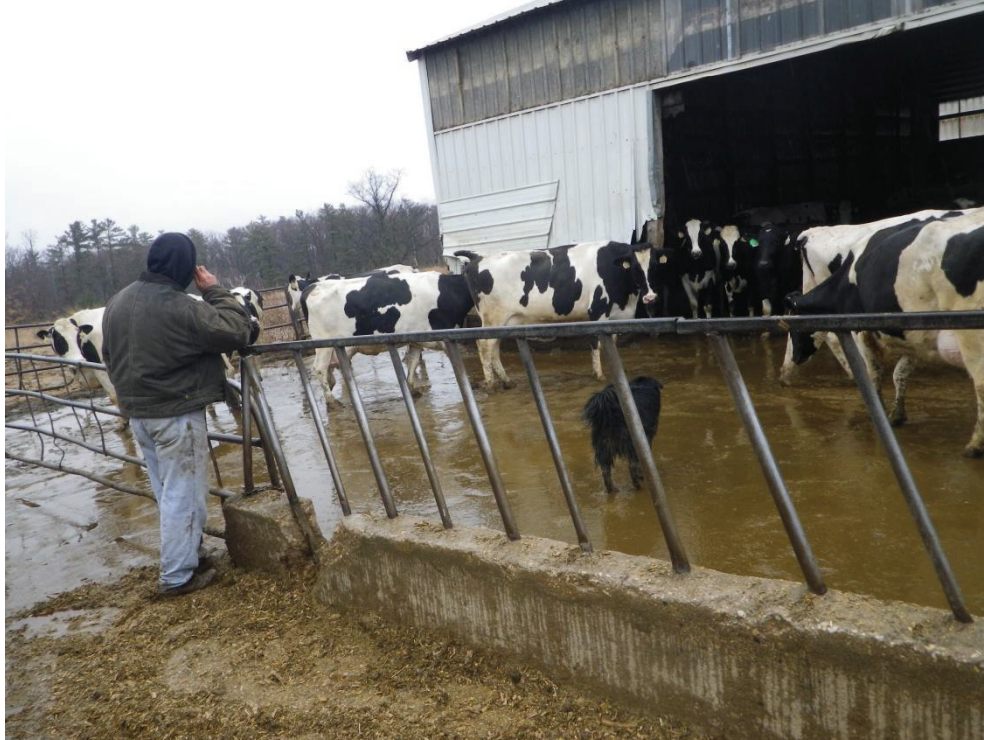
13: IMGP0266.JPG

Description: The manure and process wastewater from the open lot drains north.

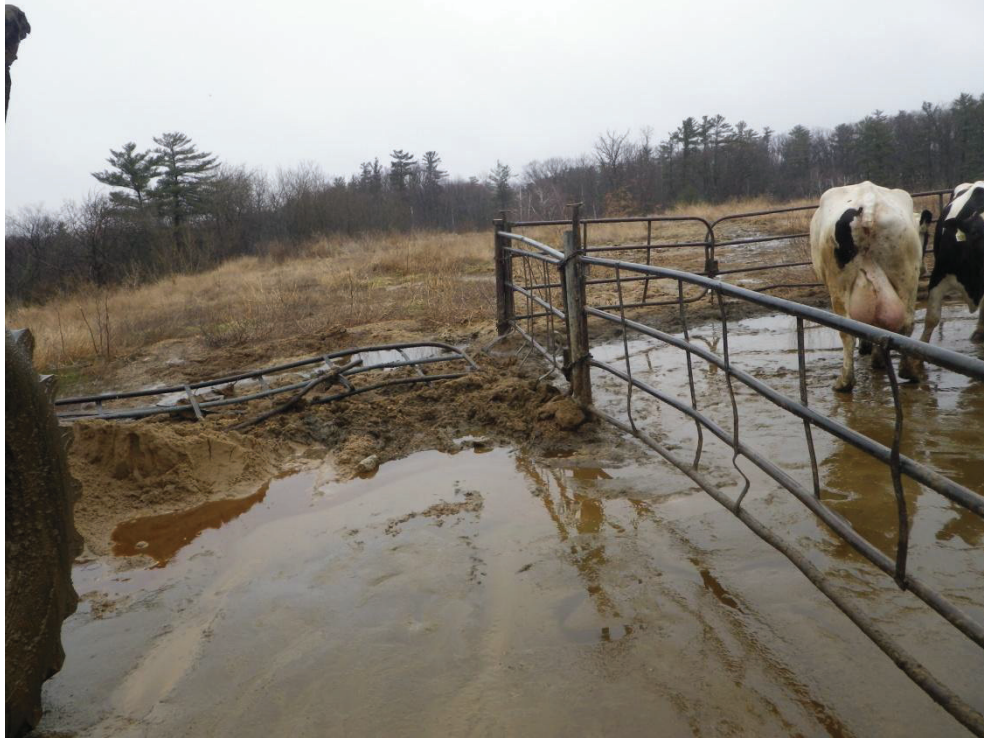
14: IMGP0267.JPG

Description: Feed solids, bedding, manure, and process waste water flowed north between the Feed Bunker and Milk Cow Barn and outlet into a field that was once used as an open lot. Feed, manure, and process wastewater were ponded in the field.

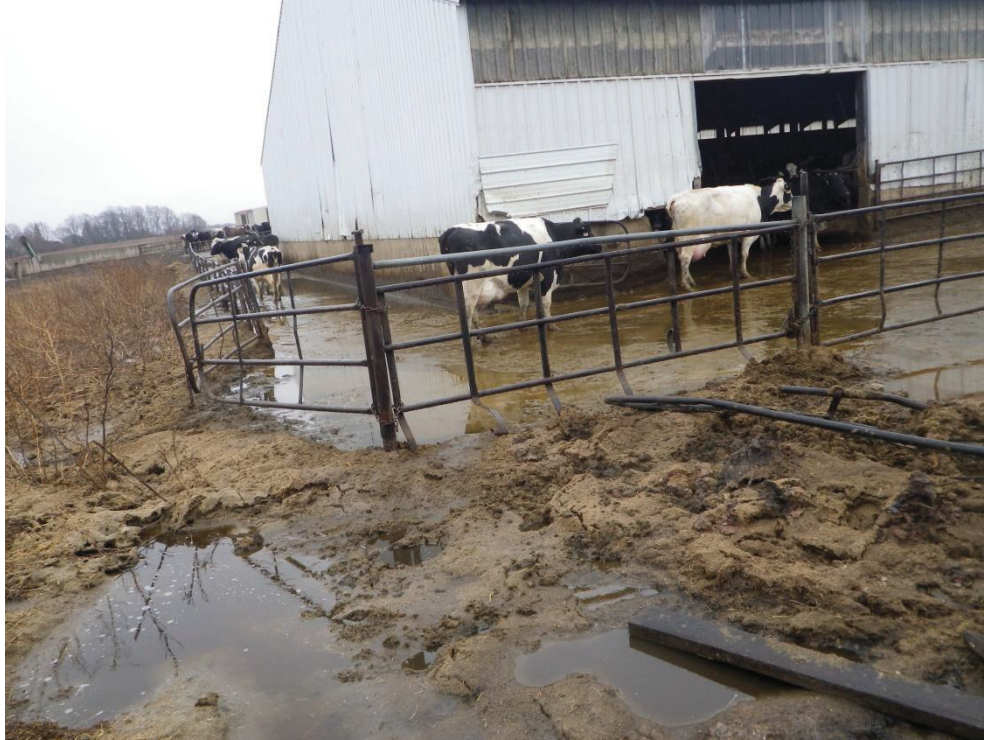
15: IMGP0268.JPG

Description: The open lot drained to the north.

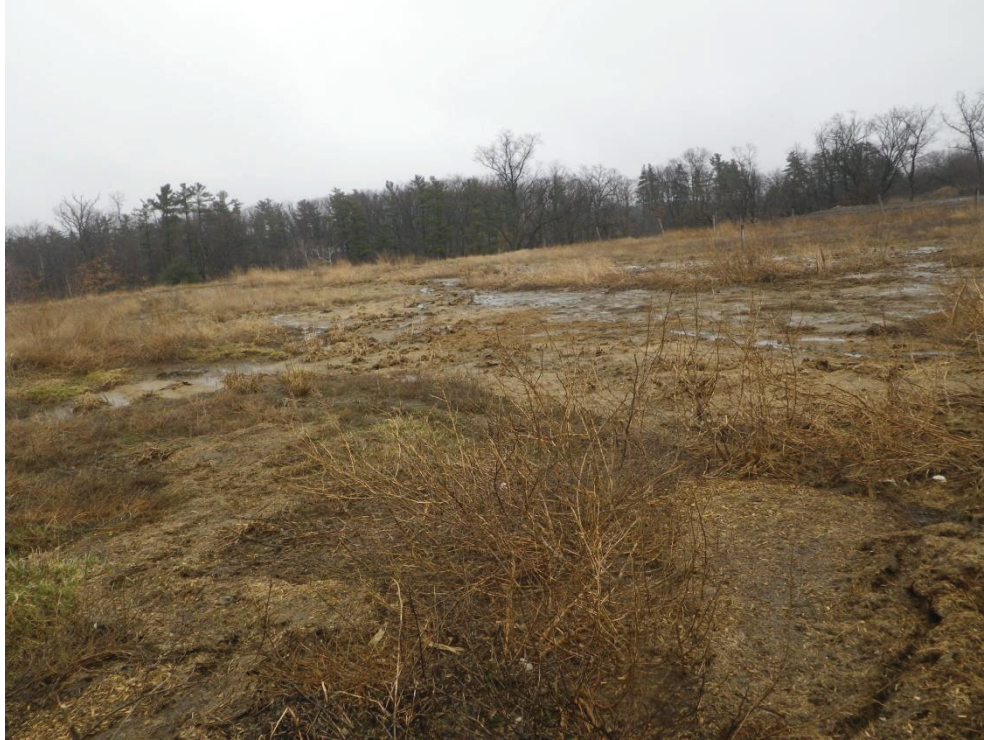
16: IMGP0269.JPG

Description: Feed, bedding, and manure solids were observed throughout the field north of the Milk Cow Barn. The field sloped to the north.

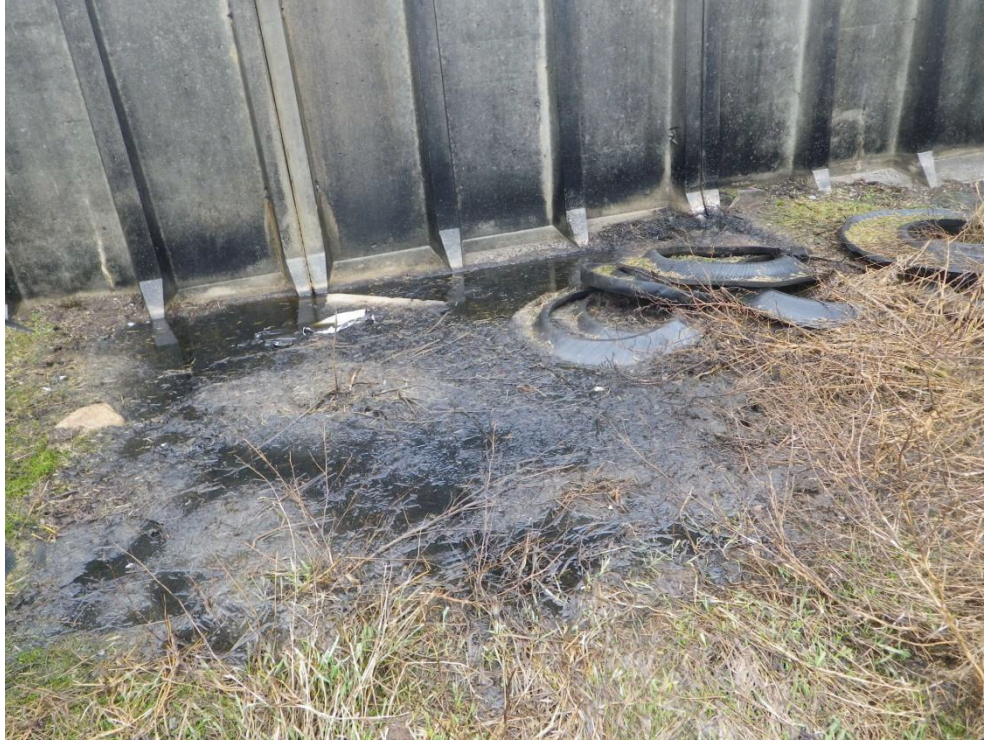
17: IMGP0270.JPG

Description: Leachate was observed at the north end of the Feed Bunker.

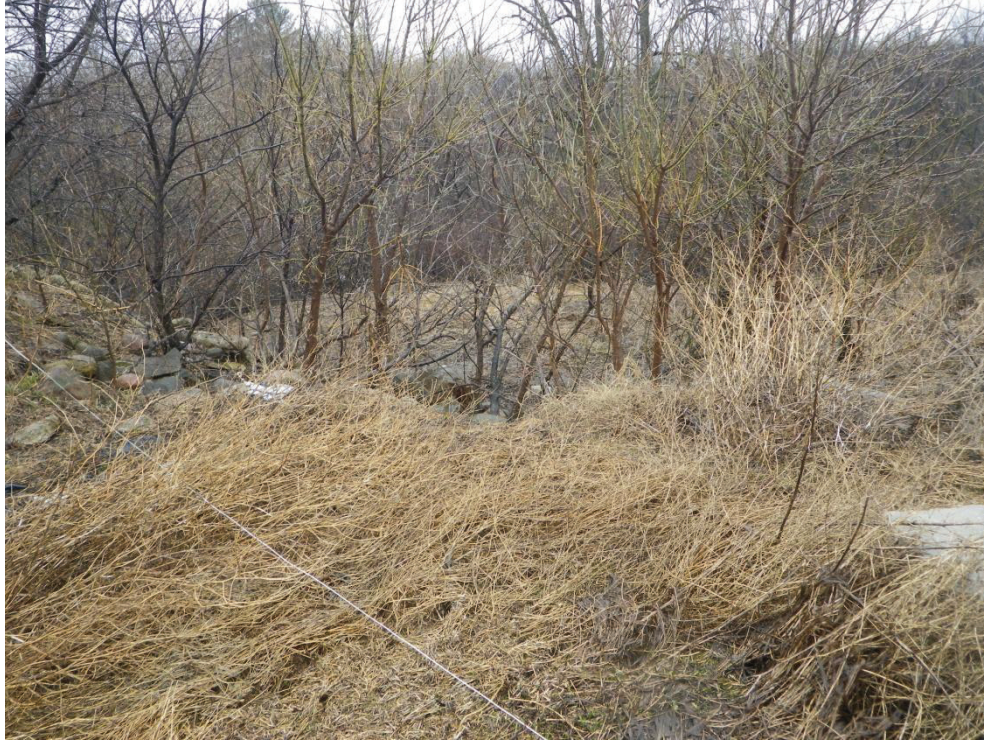
18: IMGP0271.JPG

Description: The leachate from the Feed Bunker looked as if could flow west off the ledge at the north end of the Feed Bunker.

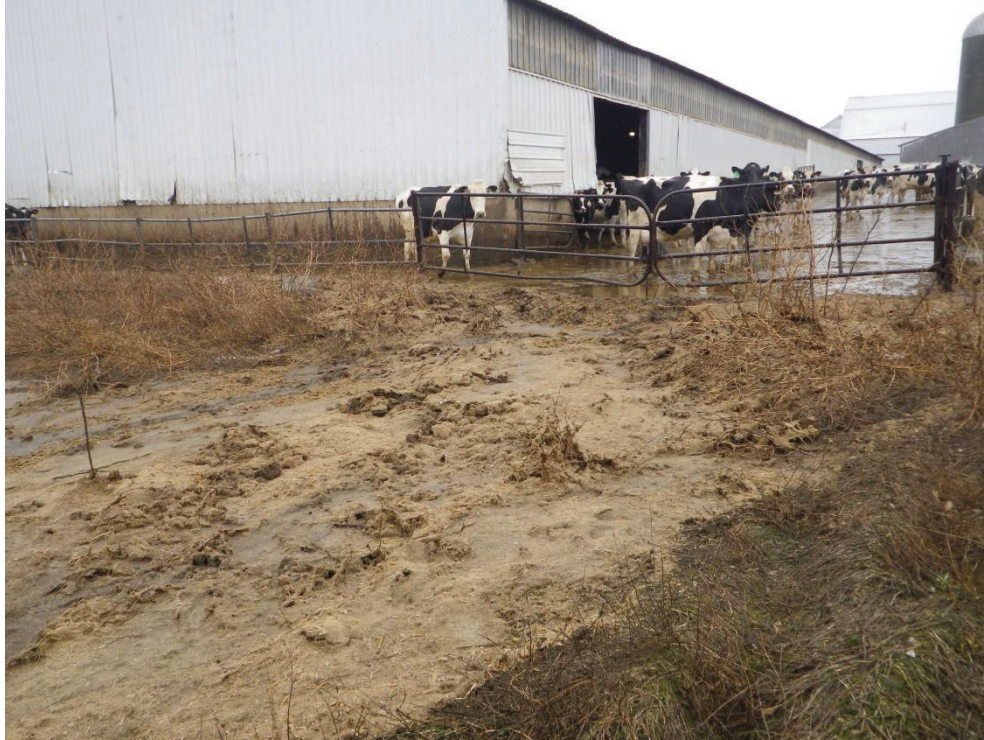
19: IMGP0272.JPG

Description: Feed, bedding, manure, and process waste water flowed to the north. Feed and manure solids were observed throughout the field on the north end of the Milk Cow Barn.

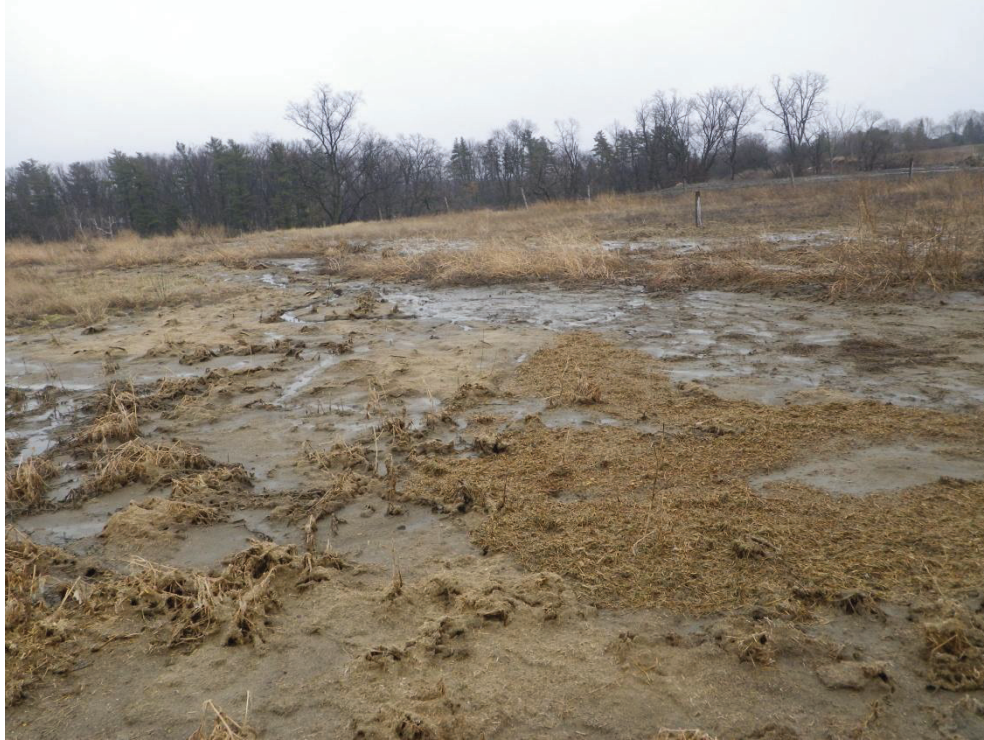
20: IMGP0273.JPG

Description: Feed, bedding, and manure solids were observed throughout the field north of the Milk Cow Barn. Manure and process wastewater were ponded throughout the field. The area drained to the north.

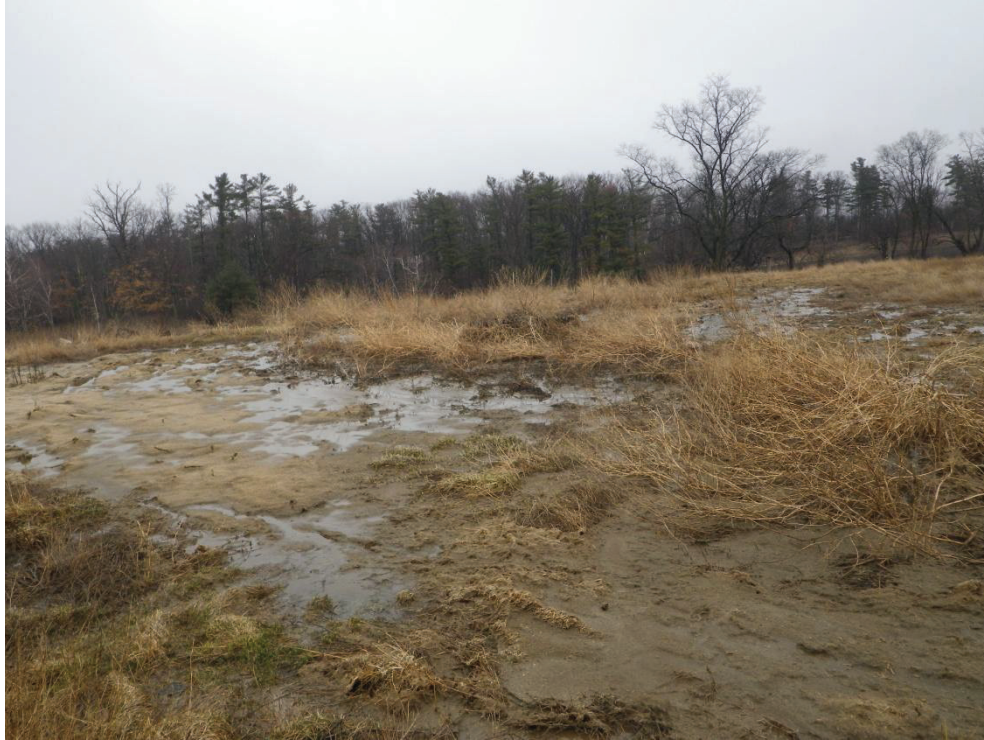
21: IMG0274.JPG

Description: Feed, bedding, and manure solids were observed throughout the field north of the Milk Cow Barn. Manure and process wastewater were ponded throughout the field. The area drained to the north.

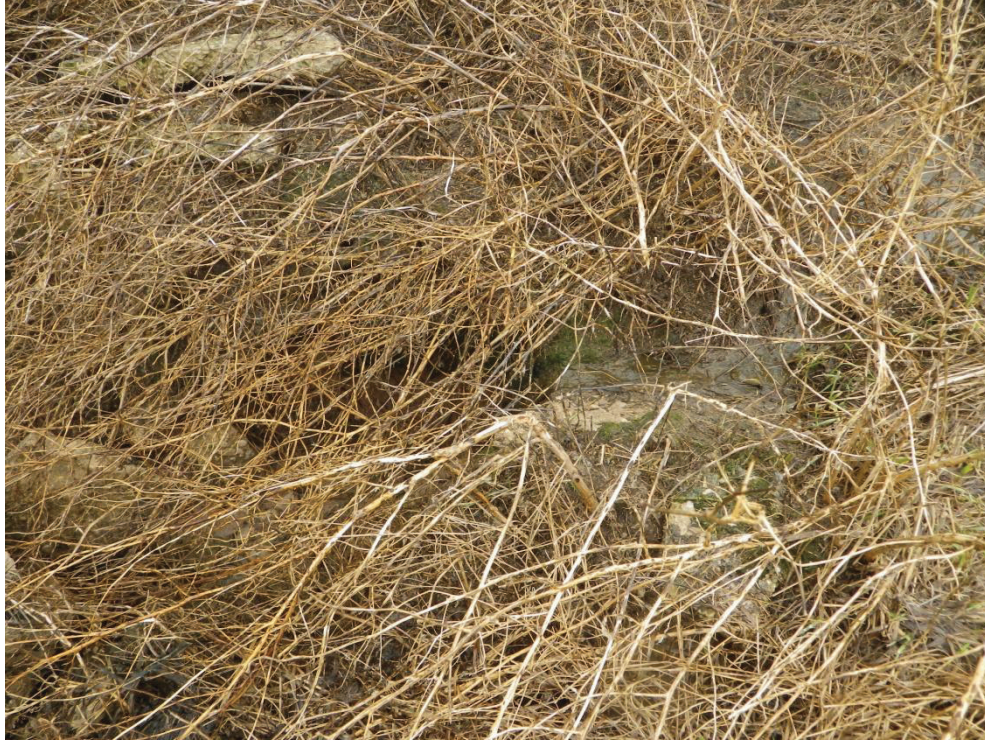
22: IMGP0275.JPG

Description: Flow from the field concentrated into multiple pathways.

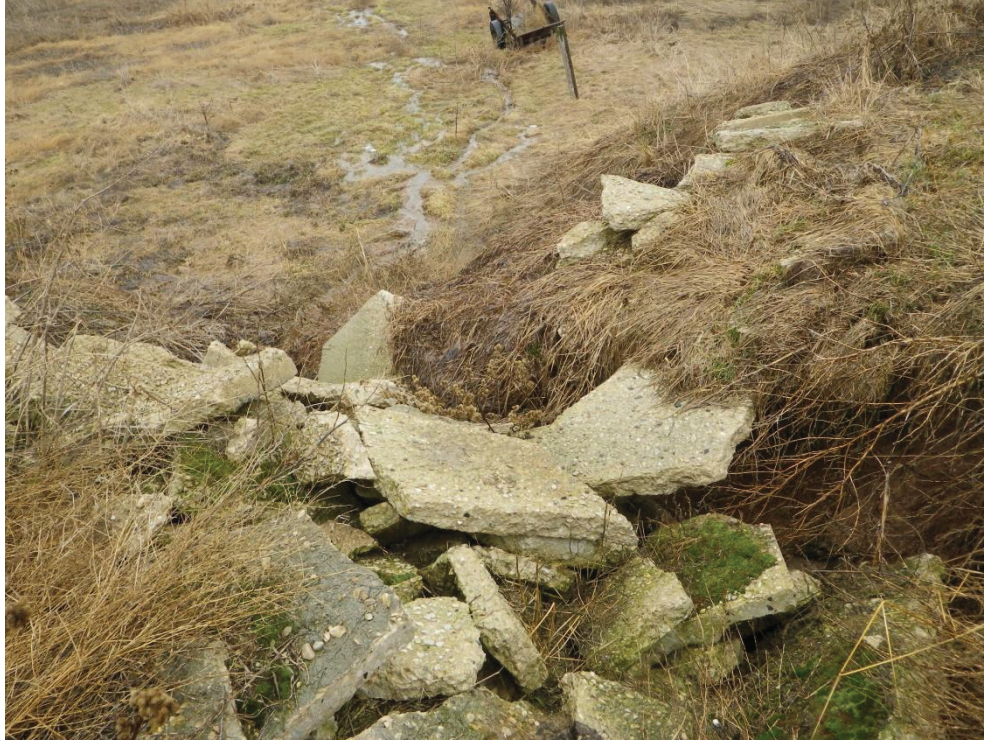
23: IMGP0276.JPG

Description: A pathway flows to the north through the field north of the Milk Cow Barn. Rip rap was placed throughout the pathway along the elevation drop.

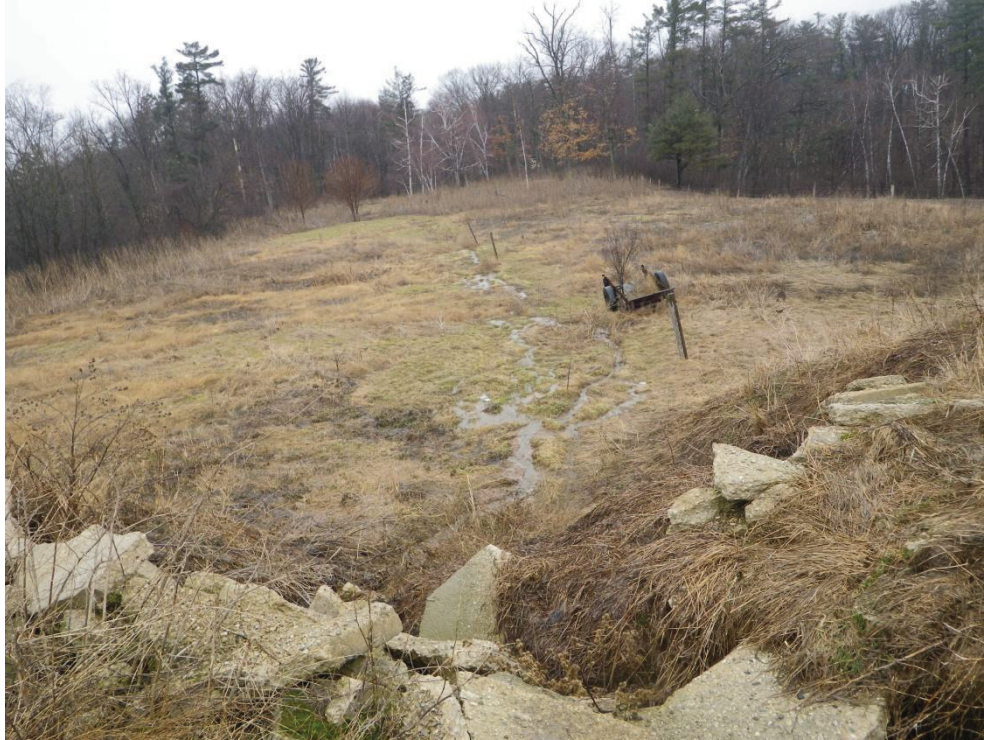
24: IMGP0277.JPG

Description: The pathway continues north through the field north of the Milk Cow Barn and then continues west near the two small trees in the background. The pathway flows to the unnamed tributary.

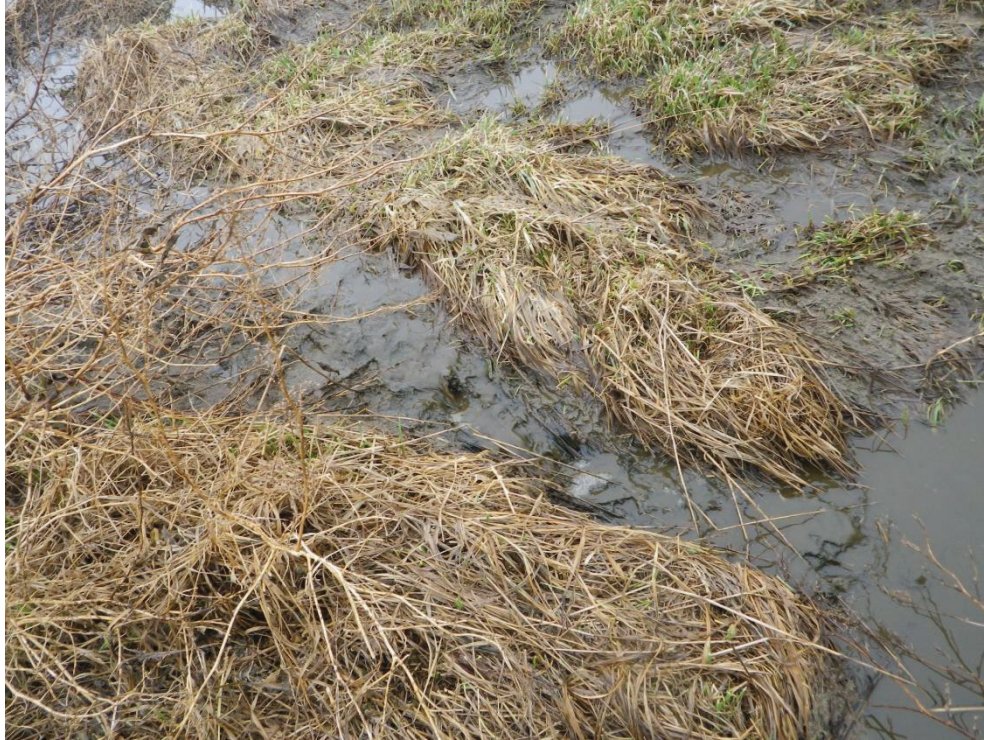
25: IMGP0278.JPG

Description: Flow in the pathway in the field north of the Milk Cow Barn.

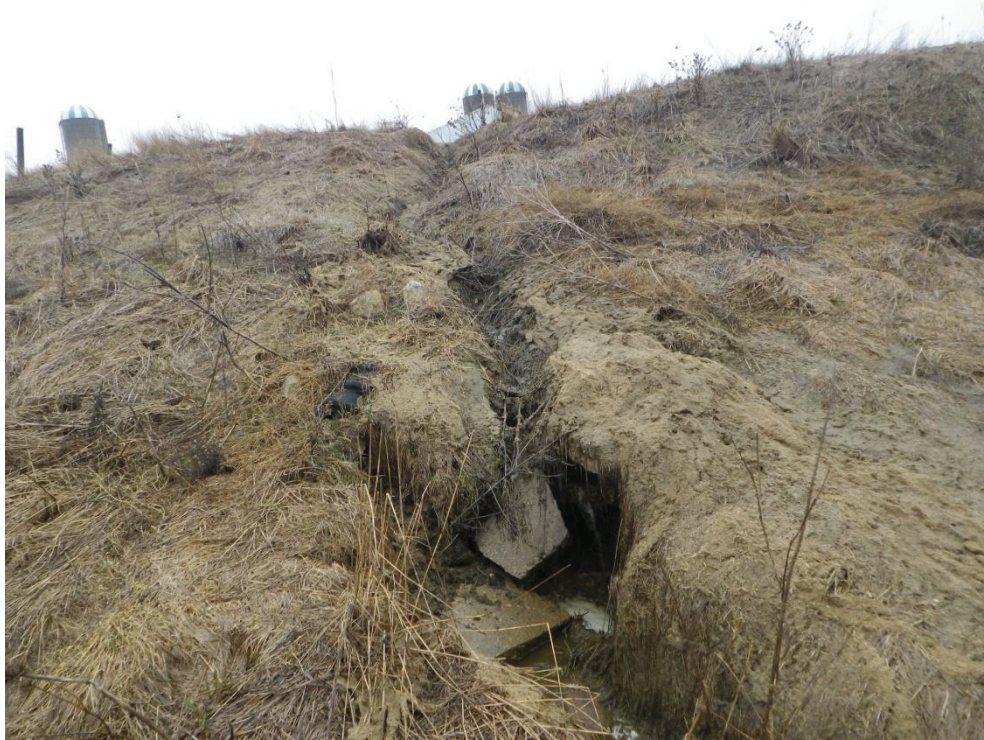
26: IMGP0279.JPG

Description: Another flow pathway/gully was observed on the east end of the field north of the Milk Cow Barn. Manure, feed, and bedding material were observed throughout the pathway. The flow in the pathway looked like the liquid that would be in a manure storage pond or slurry storage.

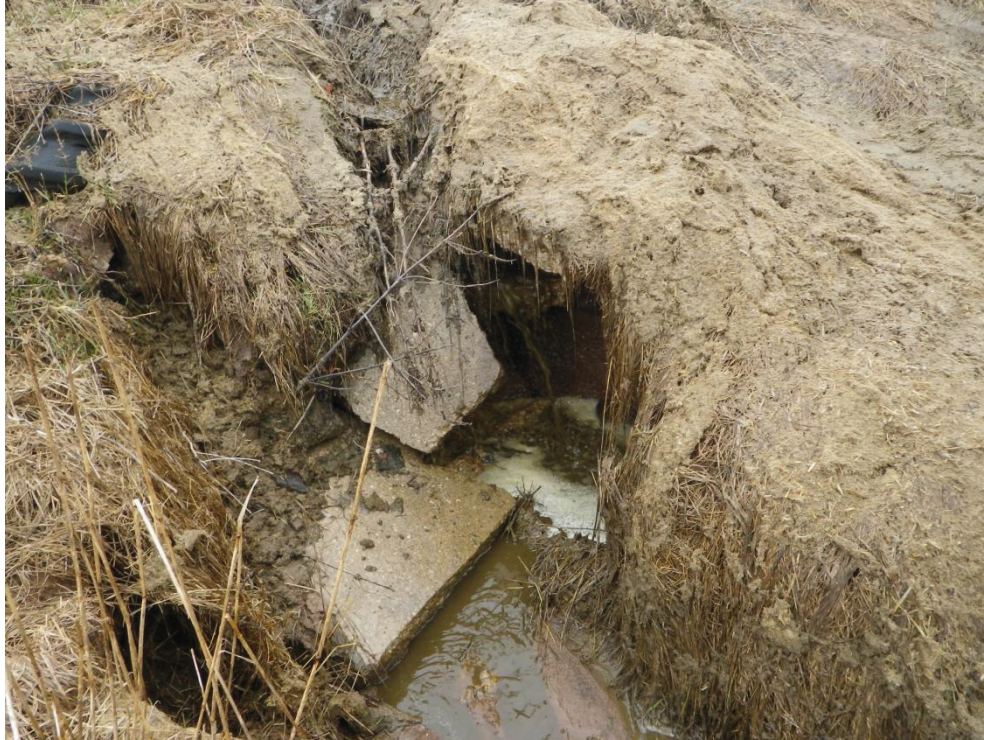
27: IMGP0280.JPG

Description: Another flow pathway/gulley was observed on the east end of the field north of the Milk Cow Barn. Manure, feed, and bedding material were observed throughout the pathway. The flow in the pathway looked like the liquid that would be in a manure storage pond or slurry storage.

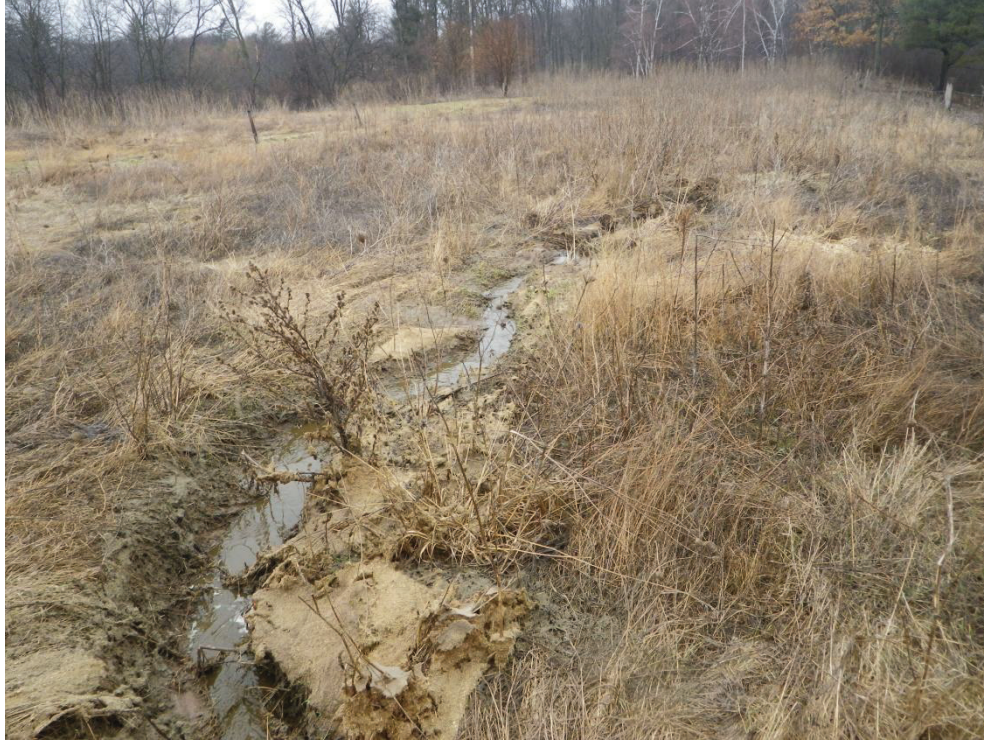
28: IMGP0281.JPG

Description: Flow continued north from the pathway/gully on the east end of the field north of the Milk Cow Barn.

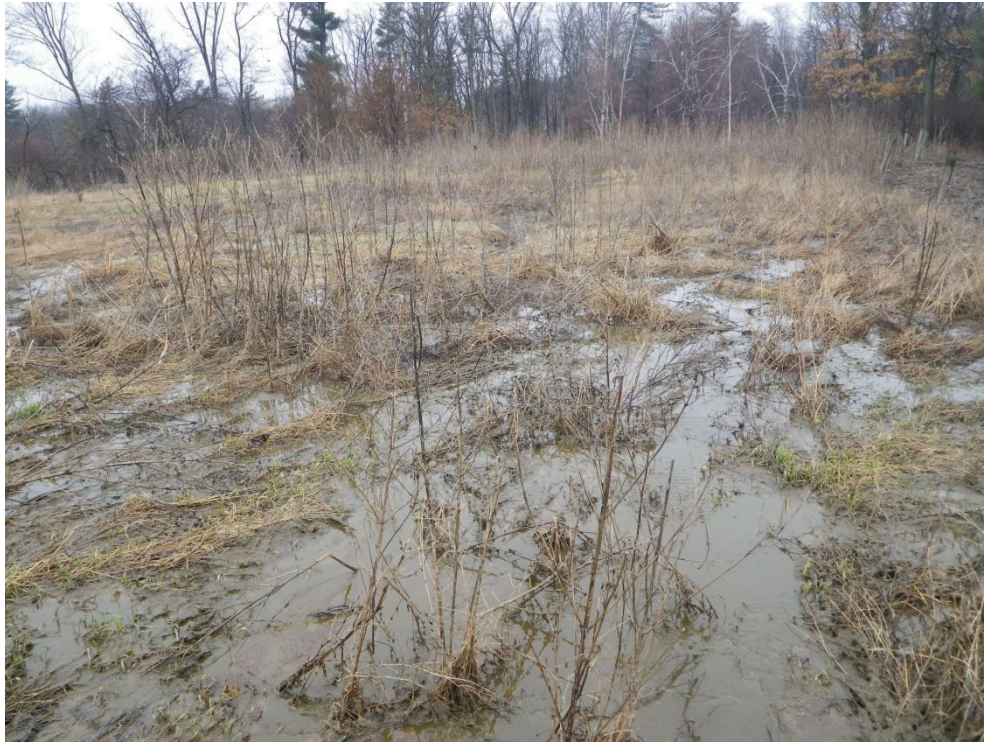
29: IMG0282.JPG

Description: The flow from the east pathway ponded at the end of the field. Portions of this area drained to the west and connected with the other pathway. Other portions of the flow continued north in a pathway that eventually dissipated. On the east side of the ponded area there was an eroded pathway that continued east, however, flow was not observed in this pathway during the inspection.
